Recent case studies

Stay tuned

What is the best way to stay on top of oil and fuel analysis and maintenance projects to ensure you are not eventually faced with major problems?

Stephen Perkins, S.J. Perkins Marine Consultants Ltd, UK

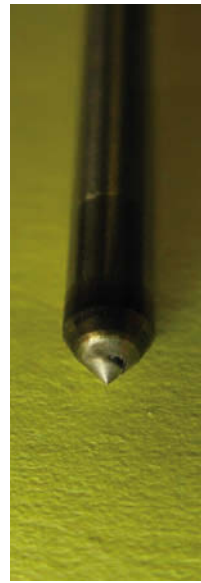
A motor yacht, with a gross tonnage of 2,157 metric tons, was experiencing wide deviation in exhaust gas temperatures for its MTU16V4000 main engines. The temperatures ranged from 467°C to 644°C. The fuel injectors were removed for inspection, and damage to the injector needles was found.

ABOVE MIDDLE: Starboard main engine no. 4 cylinder injector needle showing damage due to poor fuel

Fuel samples were received and tested by the company and the analysis indicated a flash point of 49°C, which is below the legal requirement by SOLAS. Further testing by Gas Chromatography–Mass Spectrometry (GC-MS) confirmed that the fuel was contaminated with approximately 1% gasoline.

A refit was planned for the vessel and a full endoscopic inspection of the main engines carried out. The results indicated no visible damage to the piston crowns, liners or valves, and it was not necessary to lift the cylinder heads. All the injectors on these

common-rail main engines were replaced and the fuel was off-loaded.

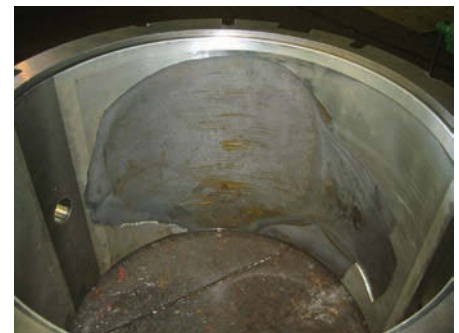
The company carried out marine distillate fuel analysis on another motor yacht, with a slightly smaller gross tonnage of 2,054 metric tons. The vessel in question recently bunkered 80,000 liters of automotive diesel and began experiencing problems when using the fuel. One symptom was sticking fuel injector poppet valves in the Caterpillar C18 generator engines. Further inspection of the fuel system revealed a sticky residue in the Alfa Laval purifier bowl. The chief engineer reported that it was an ongoing procedure to remove this residue from the purifier. On examining the fuel tanks, they, too, were found to have a thin coating of the sticky residue lining the walls and tank bottoms.

Samples of the fuel were received by the company for analysis. The fuel was in two phases – a liquid and a solid. The analysis showed the liquid phase to consist primarily of diesel, fatty acid methyl ester (FAME) and water. The solid phase consisted of a trace of partially converted fat, namely monoglycerides and diglycerides, but mainly two types of

OPPOSITE PAGE AND ABOVE TOP: Alfa Laval purifier bowl and settling tank showing a sticky residue

carboxylic acid salts (soaps). These soaps are principally fatty acids that have reacted with metals and amino compounds. The origin of the fatty acids, in the case of FAME production from pure fats or vegetable oils, would be from incomplete conversion into FAME. This is a known problem and usually these by-products are removed successfully, but trace amounts of such contamination are acceptable. The vessel requested that the supplier off-loaded the fuel. In this case, the vessel requested that the supplier off-loaded the fuel.
